**Flood Control Project Maintenance
Levee Inspections**
LMA District Cover Sheet
Spring 2015 Levee Inspection Results

Knights Landing Ridge Drainage District

Spring 2015 Levee Inspection Results

Waterway			Bank	Unit Miles
Unit No. 01 Knights Landing Ridge Cut			Right	6.36
	Spring (March - May)	Summer (June - August)	(September - November) Fall	Winter (December - February)
Unit Maintenance Rating (Fall Only)				
Date of Inspection	04/23/2015 - 04/23/2015			
DWR Inspector	Jai Lor			
Accompanied By

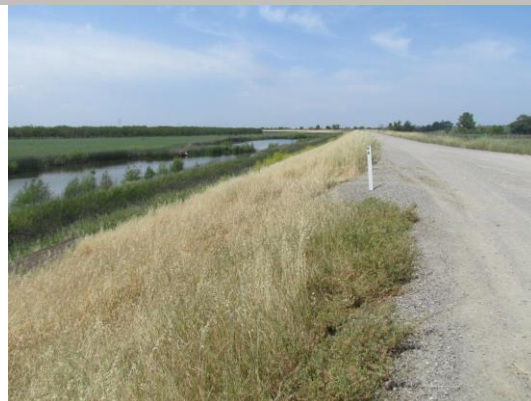
Photo 1 of 1 : SP_2015_NA0008_256_14_20150423_00013.jpg

LM Start	0.00	Rating **	M	Issue No.	14
LM End	6.34	Issue Type +	Ma	Location *	LS
Category	Earthen Levee			GPS Latitude/Longitude	
				Start	End
Item	Vegetation			38.719088 °	38.792433 °
				-121.664146 °	-121.726610 °
DWR ID	DWR_NA0008_01_s _ 2015_14				
Action/Comments					
Control annual grass and weeds on the levee slopes and easements.

View of the vegetation on the landward side of the levee looking upstream. Spring 2015.

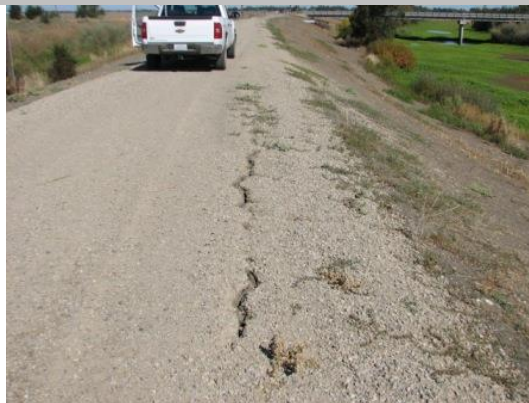
Photo 1 of 1 : SP_2015_NA0008_256_19_20150401_00003.jpg

LM Start	2.58	Rating **	A/W	Issue No.	19
LM End	2.58	Issue Type +	Ma	Location *	WS
Category	Earthen Levee			GPS Latitude/Longitude	
				Start	End
Item	Cracking			38.747218 °	38.747218 °
				-121.694450 °	-121.694450 °
DWR ID	DWR_NA0008_01_f_2013_19				
Action/Comments					
Monitor and have inspected by geotechnical engineer.					
Inspector Comments: Cracks along crown and down waterside slope.

Cracking along the waterside shoulder of the crown the length of 20 feet.
Fall 2013

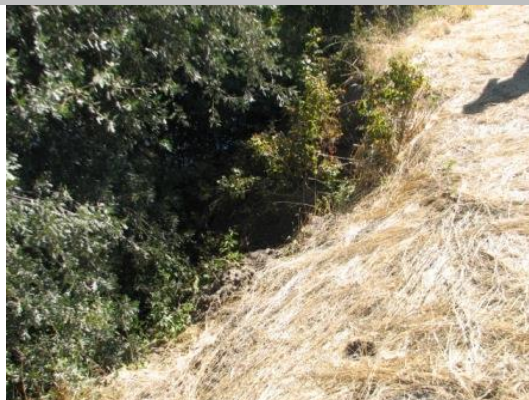
Photo 1 of 2 : SP_2015_NA0008_256_20_20150401_00004.jpg

LM Start	3.50	Rating **	M	Issue No.	20
LM End	3.50	Issue Type +	Ma	Location *	WS
Category	Earthen Levee			GPS Latitude/Longitude	
				Start	End
Item	Erosion / Bank Caving			38.759910 °	38.759910 °
				-121.696920 °	-121.696920 °
DWR ID	DWR_NA0008_01_f_2013_20				
Action/Comments					
Note and monitor erosion site.

Another view of the erosion cutting into the slope. Fall 2013

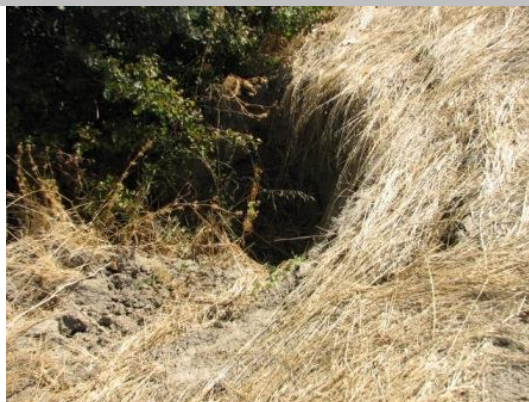
Photo 2 of 2 : SP_2015_NA0008_256_20_20150401_00005.jpg

Deep erosion at the bottom of the waterside slope 3-4 foot cut. Fall 2013

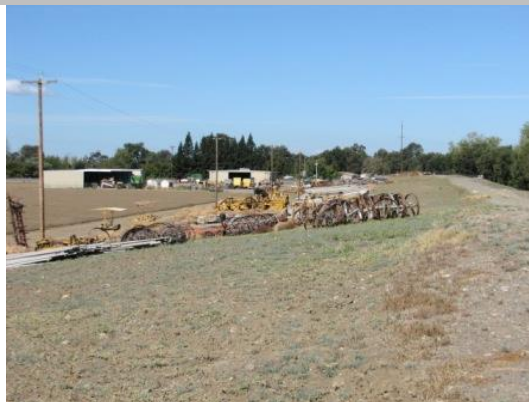
Photo 1 of 2 : SP_2015_NA0008_256_7_20150401_00001.jpg

LM Start	6.10	Rating **	M	Issue No.	7
LM End	6.34	Issue Type +	Ma	Location *	LS
Category	Earthen Levee			GPS Latitude/Longitude	
				Start	End
Item	Encroachments			38.790007 °	38.792433 °
				-121.723308 °	-121.726463 °
DWR ID	DWR_NA0008_01_s_2012_7				
Action/Comments					
Equipment

Equipment and irrigation pipe lays on the landside levee slope. Fall 2013

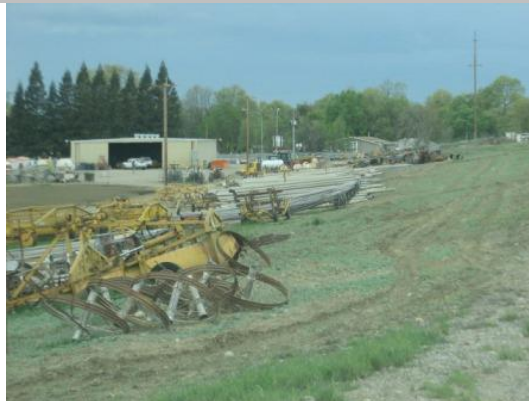
Photo 2 of 2 : SP_2015_NA0008_256_7_20150401_00002.jpg

LM Start	6.10	Rating **	M	Issue No.	7 (cont)	
LM End	6.34	Issue Type +	Ma	Location *	LS	
Category	Earthen Levee			GPS Latitude/Longitude		
				Start		End
Item	Encroachments			38.790007 °	38.792433 °	
				-121.723308 °	-121.726463 °	
DWR ID	DWR_NA0008_01_s _ 2012_7					
Action/Comments						
Equipment

A current view of the equipment on the levee slope. Spring 2014

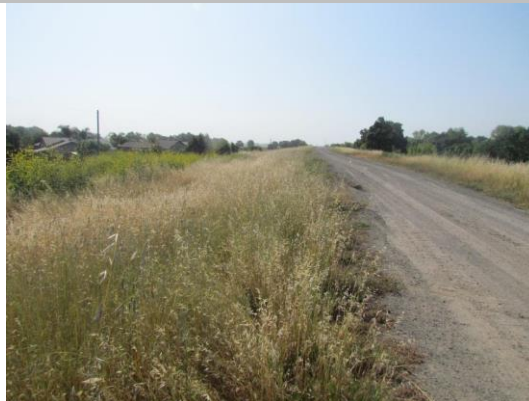
Photo 1 of 1 : SP_2015_NA0008_257_13_20150423_00015.jpg

LM Start	0.00	Rating **	M	Issue No.	13
LM End	5.92	Issue Type +	Ma	Location *	LS
Category	Earthen Levee			GPS Latitude/Longitude	
				Start	End
Item	Vegetation			38.724259 °	38.792471 °
				-121.665230 °	-121.723844 °
DWR ID	DWR_NA0008_02_s _ 2015_13				
Action/Comments					
Control annual grass and weeds on the levee slopes and easements.

View of the vegetation on the landward side of the levee looking downstream. Spring 2015.

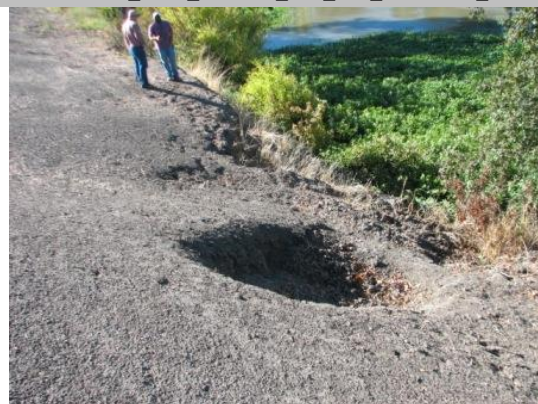
Photo 1 of 1 : SP_2015_NA0008_257_230_20150401_00010.jpg

LM Start	3.02	Rating **	U	Issue No.	230
LM End	3.02	Issue Type +	Ma	Location *	WS
Category	Earthen Levee			GPS Latitude/Longitude	
				Start	End
Item	Erosion / Bank Caving			38.759112 °	38.759112 °
				-121.693638 °	-121.693638 °
DWR ID	DWR_NA0008_02_f_2013_230				
Action/Comments					
Note and monitor erosion site.

Erosion at the bottom of the slope. It appears that a fallen tree has caused a sink hole. Fall 2013

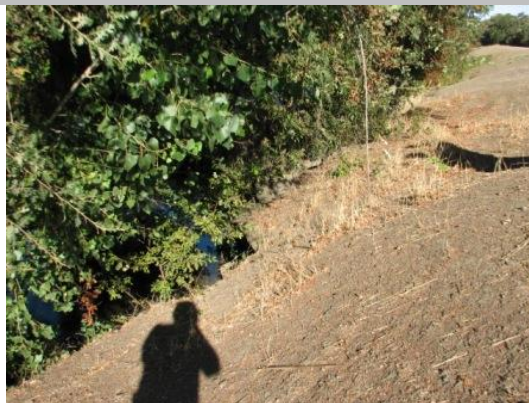
Photo 1 of 2 : SP_2015_NA0008_257_229_20150401_00008.jpg

LM Start	3.06	Rating **	U	Issue No.	229
LM End	3.06	Issue Type +	Ma	Location *	WS
Category	Earthen Levee			GPS Latitude/Longitude	
				Start	End
Item	Erosion / Bank Caving			38.759542 °	38.759542 °
				-121.694007 °	-121.694007 °
DWR ID	DWR_NA0008_02_f_2013_229				
Action/Comments					
Note and monitor erosion site. Inspector Comments: Erosion is undermining large oak tree and is growing.

Another view of the vertical cut at the bottom of the slope. Fall 2013

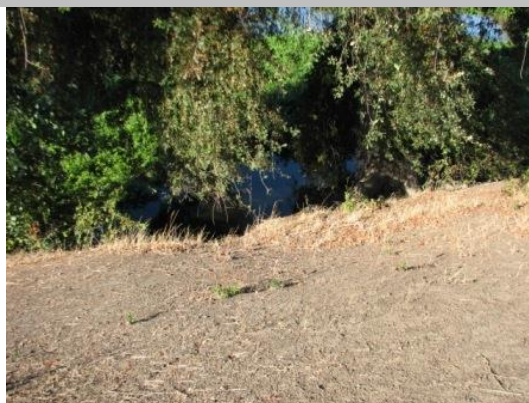
Photo 2 of 2 : SP_2015_NA0008_257_229_20150401_00009.jpg

Waterside eroison vertical cut at bottom of slope. Fall 2013

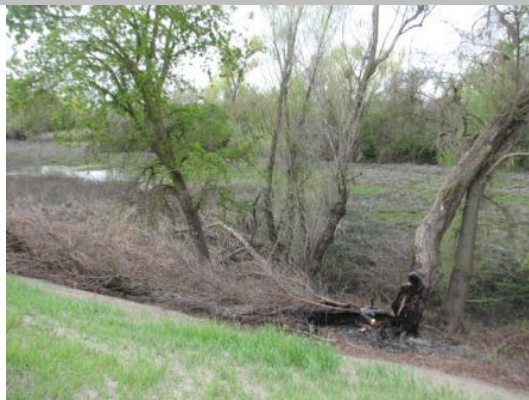
Photo 1 of 1 : SP_2015_NA0008_257_15_20150401_00004.jpg

LM Start	4.56	Rating **	U	Issue No.	15
LM End	4.56	Issue Type +	Ma	Location *	WS
Category	Earthen Levee			GPS Latitude/Longitude	
				Start	End
Item	Vegetation			38.778402 °	38.778402 °
				-121.706022 °	-121.706022 °
DWR ID	DWR_NA0008_02_s_2014_15				
Action/Comments					
Trees / Woody Vegetation

A cottonwood tree may have been struck by lightning. The tree is split into three parts. Spring 2014

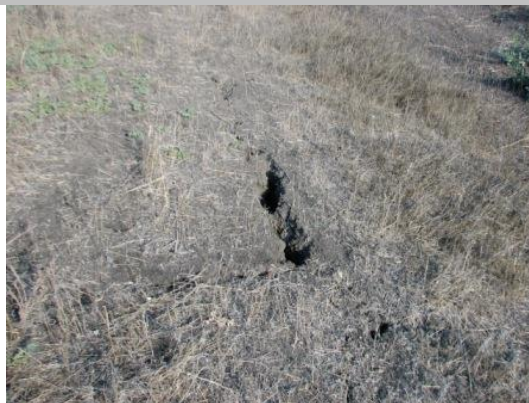
Photo 1 of 1 : SP_2015_NA0008_257_226_20150401_00005.jpg

LM Start	4.79	Rating **	A/W	Issue No.	226
LM End	4.82	Issue Type +	Ma	Location *	LS
Category	Earthen Levee			GPS Latitude/Longitude	
				Start	End
Item	Cracking			38.780858 °	38.781102 °
				-121.709093 °	-121.709385 °
DWR ID	DWR_NA0008_02_f_2013_226				
Action/Comments					
Monitor and have inspected by geotechnical engineer.

Cracking on the landside is 3-4 inches wide and 12 inches deep. Fall 2013

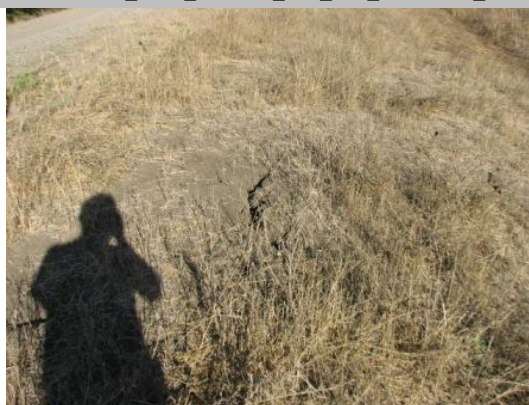
Photo 1 of 2 : SP_2015_NA0008_257_227_20150401_00006.jpg

LM Start	4.79	Rating **	A/W	Issue No.	227
LM End	4.79	Issue Type +	Ma	Location *	WS
Category	Earthen Levee			GPS Latitude/Longitude	
				Start	End
Item	Cracking			38.780858 °	38.780858 °
				-121.709095 °	-121.709095 °
DWR ID	DWR_NA0008_02_f_2013_227				
Action/Comments					
Monitor and have inspected by geotechnical engineer.

Another view of the cracking on the levee slope. Fall 2013

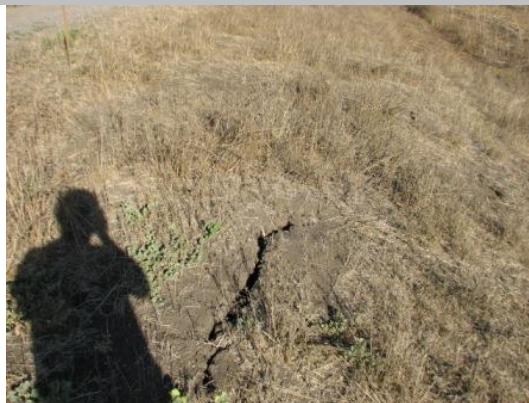
Photo 2 of 2 : SP_2015_NA0008_257_227_20150401_00007.jpg

LM Start	4.79	Rating **	A/W	Issue No.	227 (cont)
LM End	4.79	Issue Type +	Ma	Location *	WS

Cracking on levee slope 1-2 inches wide and 6 inches deep. Fall 2013

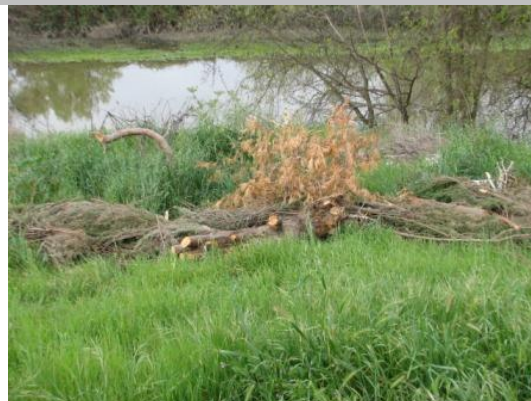
Photo 1 of 1 : SP_2015_NA0008_257_12_20150401_00003.jpg

LM Start	5.94	Rating **	M	Issue No.	12
LM End	5.94	Issue Type +	En	Location *	WS
Category	Earthen Levee			GPS Latitude/Longitude	
				Start	End
Item	Encroachments			38.792661 °	38.792661 °
				-121.724047 °	-121.724047 °
DWR ID	DWR_NA0008_02_s_2014_12				
Action/Comments					
Debris

A debris pile is on the waterside levee slope. Spring 2014

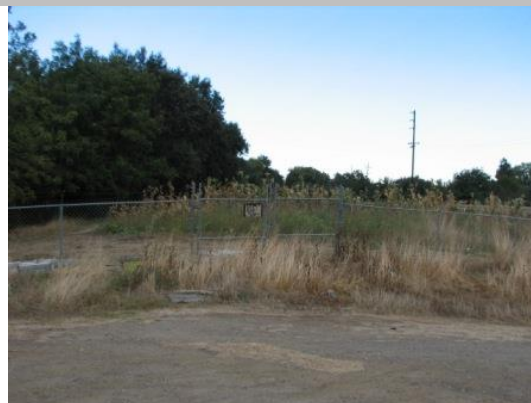
Photo 1 of 2 : SP_2015_NA0008_257_1_20150401_00001.jpg

LM Start	5.94	Rating **	M	Issue No.	1
LM End	5.94	Issue Type +	En	Location *	LS
Category	Earthen Levee			GPS Latitude/Longitude	
				Start	End
Item	Encroachments			38.792735 °	38.792735 °
				-121.724092 °	-121.724092 °
DWR ID	DWR_NA0008_02_s_2012_1				
Action/Comments					
Crops					
Inspector Comments: No access; strawberries are being grown					
landside levee slope and crown

Strawberry patch on the levee crown has added other crops on the crown. Fall 2013

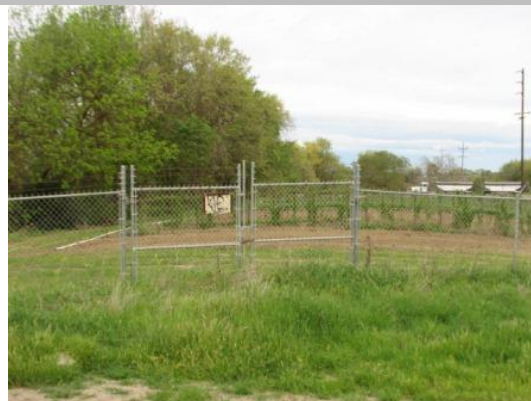
Photo 2 of 2 : SP_2015_NA0008_257_1_20150401_00002.jpg

LM Start	5.94	Rating **	M	Issue No.	1 (cont)
LM End	5.94	Issue Type +	En	Location *	LS

Crops (strawberries and berry vines) are planted on the crown with a fence blocking access. Spring 2014
